Ohau Point Ring Net and TECCO Mesh Drape

M. B Avery
Hiway Geostabilization Ltd, Auckland

ABSTRACT

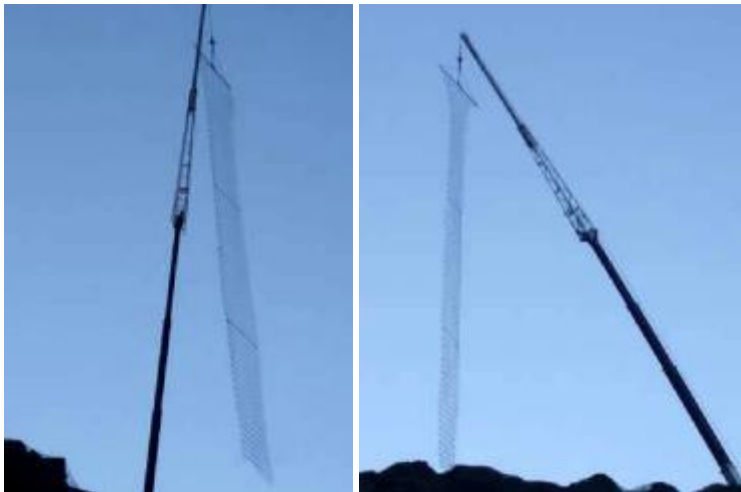
Figure 3: 60m net (left) and other net (right). Note contraction (necking of other net during lifting. (photo courtesy FHWA, 2009)
