STABILITY OF SLOPES IN THE SOFT, GLACIOLACUSTRINE DEPOSITS OF THE THUNDER BAY REGION, N.W. ONTARIO.

K.D. Eigenbrod, Department of Civil Engineering Lakehead University, Thunder Bay, Ontario, P7B 5E1

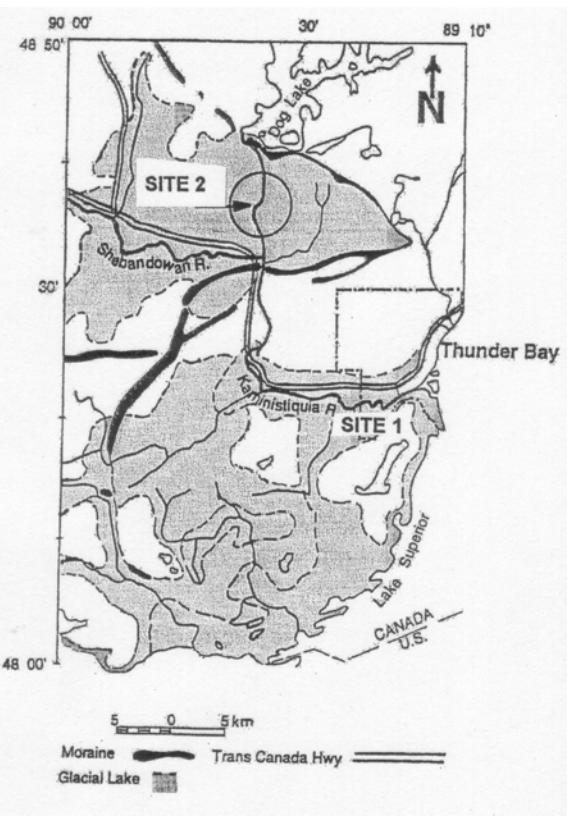
Fig. 2 Site plan of Kaministiquia River area (Sites 1 and 2).

Shallow ground movements can be commonly observed on grassy slopes of the Upper Kaministiquia River valley (Site 2 on Fig. 2), whereas forested slopes appear stable unless they are undercut by natural or man-made causes (Eigenbrod and Kaluza 1999). The slope failures occur in the red high-plastic clays of the area which typically are underlain by massive clean sand and gravel deposits. The slides are characterized by generally well defined boundaries, (See Fig. 5) indicating that the slope failures were initiated in the grass-covered slopes, after they had been cleared of the original forest cover. To date, only two slides impacted on human development: one slide has been infringing on a residential building and its water supply, and another slide is the cause for continuous movements along an embankment of the Trans-Canada Highway.

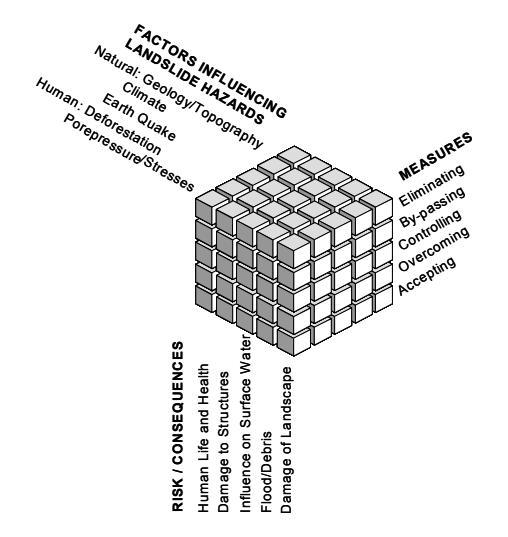
Fig. 12 Safety Cube (after Schneider, see Amann et al. 1999)

In a safety cube the hazard scenarios of engineering problems (e.g. the factors mitigating landsliding), the associated risks and consequences and the appropriate safety measures can be conveniently correlated to each other (See Fig. 12).
