# RAILWAY GROUND HAZARD RISK SCENARIO: RIVER EROSION: EARTH-SLIDE

Tim Keegan, Canadian National Railways, Edmonton, Alberta  
Brian Abbott, Canadian National Railways, Edmonton, Alberta  
Dave Cruden, University of Alberta, Edmonton, Alberta  
Iain Bruce, BGC Engineering Ltd, Vancouver, B.C.  
Mark Pritchard, BGC Engineering Ltd, Vancouver, B.C.

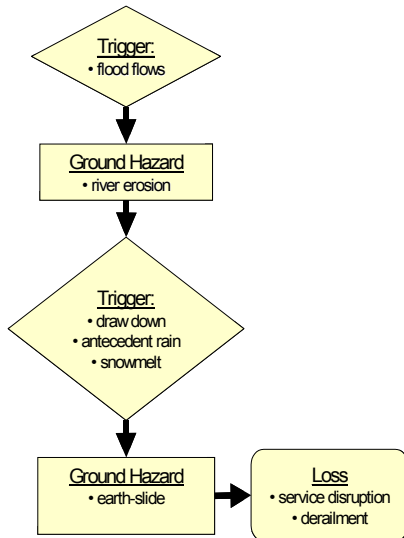
Figure 1: Flow chart of a typical river erosion: earth-slide (RE:ESI) risk scenario

Fig. 1 illustrates a typical RE:ESI risk scenario. Typically, triggered by flood flow in the river, this scenario initiates with the loss of erodible material at the toe of a slope due to river scour, a hazard event. This event may result in an over-steepened slope condition below the rail grade

raising the likelihood of an earth-slide (Cruden and Varnes, 1996), a second hazard. Intense rainfall, a triggering event (Wieczorek, 1996), may subsequently occur at the hazard location filling tension cracks and raising pore pressures. Driving forces are increased and effective stress is reduced resulting in a rapid earth-slide. This earth slide hazard poses a significant risk to train traffic as the track roadbed may be involved in the slide.

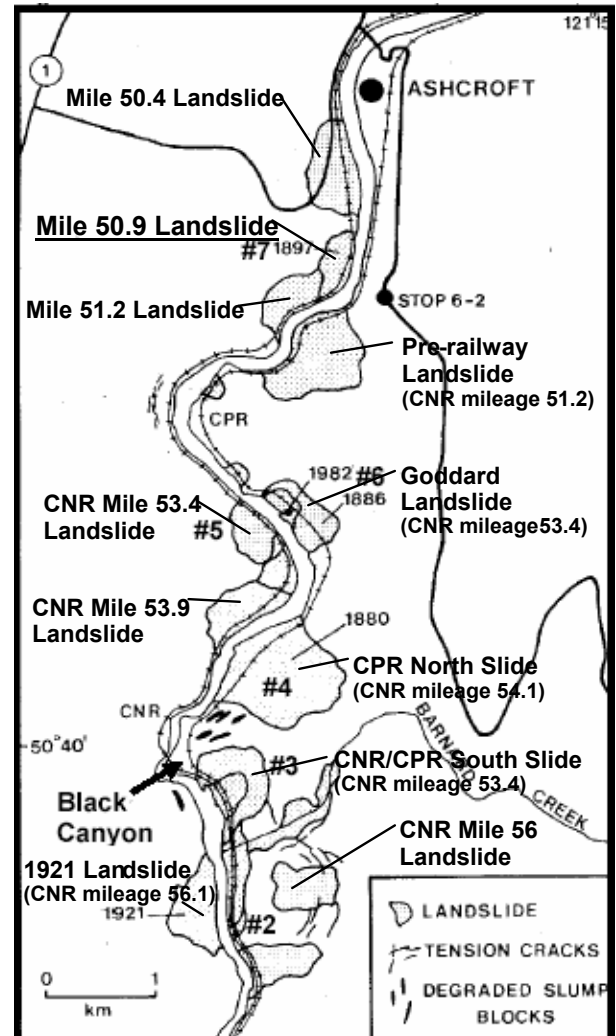
Figure 2: Location plan of Mile 50.9 Landslide and landslides south of Ashcroft (after Porter et al, 2001)

The Ashcroft Mile 50.9 Landslide is one of several large earth-slides located on both banks of the 13-kilometre reach of the Thompson River downstream of the Town of Ashcroft (Fig. 2). The landslides have been problematic to both CPR and CNR since railway construction around the end of the 19<sup>th</sup> century. The nature and character of these landslides is well documented with the earliest paper by Stanton (1898) and the most recent by Porter et al (2002).

extensive glacial lake deposits that filled the pre-glacial valley (Holland 1976). With the thalweg still well above pre-glacial valley bottom levels over most of its length (NWH, 1977), the degradation is expected to continue. As a result, the cyclic interaction between river erosion and earth-slides is also expected to continue and thus represents a risk to railway operations.

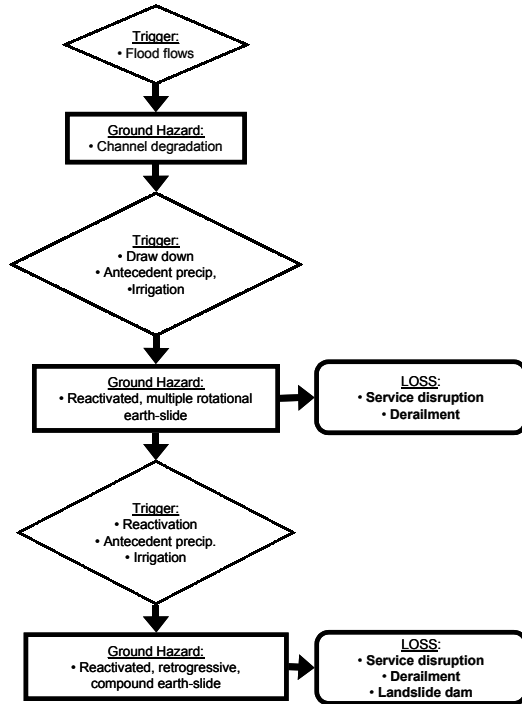
Figure 3: Flow chart depicting the Mile 50.9 Landslide Risk Scenario

The RE:ESI risk scenario at Mile 50.9 Ashcroft is summarized in Fig. 3. The first ground hazard in the scenario is a hydrotechnical river erosion hazard

specifically classed as channel degradation. This hazard event is triggered by flood flows in the river that occur in May and June of a flood year. Normally the channel

degradation does not immediately cause track failure but rather generates the conditions for a geotechnical landslide hazard classed as a reactivated multiple rotational earth-slide. These hazard events are triggered by drawdown of the river level in the fall and winter months; incremental increases in pore pressure brought on by long term antecedent precipitation or irrigation; or intense rainfall filling tension cracks. This first earth-slide hazard can and has resulted in track failure, which may lead to a significant service disruption or derailment. The more serious secondary earth-slide hazard generated by the reactivated multiple rotational earth-slide event is the retrogressive compound earth-slide hazard. This hazard event can be triggered by either stress relief resulting from reactivation of the first earth-slide hazard event or by incremental increases in pore pressure brought on by long term antecedent precipitation or irrigation. Although unlikely, the high speed and mobility associated with the secondary earth-slide hazard has the additional potential of forming a landslide dam. Following is a description of each of the components of this risk scenario starting with the earth-slide hazards.

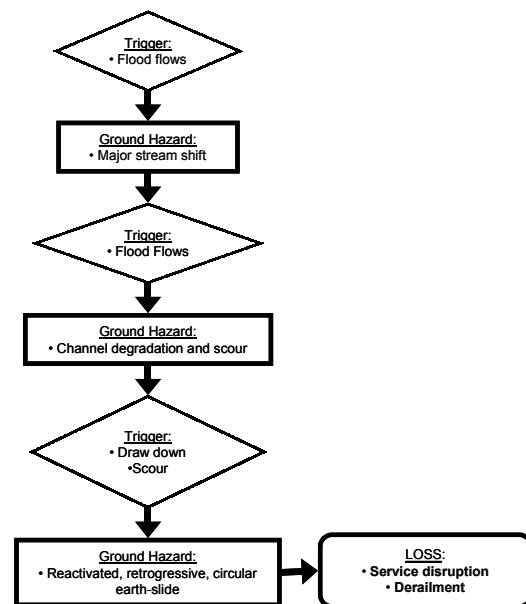
Figure 9: Flow chart depicting the Skeena Mile 28 Landslide Risk Scenario

The RE:ESI risk scenario at Mile 50.9 Ashcroft is summarized in Fig. 9. The initial ground hazard in the scenario is the major stream shifts that occur in the anabranching Skeena River which are triggered by flood flows in the river. These flood flows occur either from spring snow melt or heavy rains in the water shed. The second hazard in the scenario is classed as a combination of channel degradation and meander scour

as the new channel evolves to its mature state. This hazard event is also triggered by flood flows. The final hazard in the scenario, which inevitably results in loss to the railway, is classed as a reactivated, retrogressive earth-slide. This can be triggered by either removal of material at the toe or by draw down conditions. This event can and has resulted in track failure that may lead to a significant service disruption or derailment. Following is a description of each of the components of this risk scenario starting with the earth-slide hazards.
