# DEBRIS FLOW HAZARD AT FIVE MILE CREEK, BANFF, ALBERTA

Simon Cullum-Kenyon, Thurber Engineering Ltd., Calgary, Alberta, Canada  
Heinrich K. Heinz, Thurber Engineering Ltd., Calgary, Alberta, Canada  
John C. Sobkowicz, Thurber Engineering Ltd., Calgary, Alberta, Canada  
Doug VanDine, VanDine Geological Engineering Ltd., Victoria, BC, Canada  
Doug Kerr, Parks Canada – Highways Service Centre, Banff, Alberta, Canada

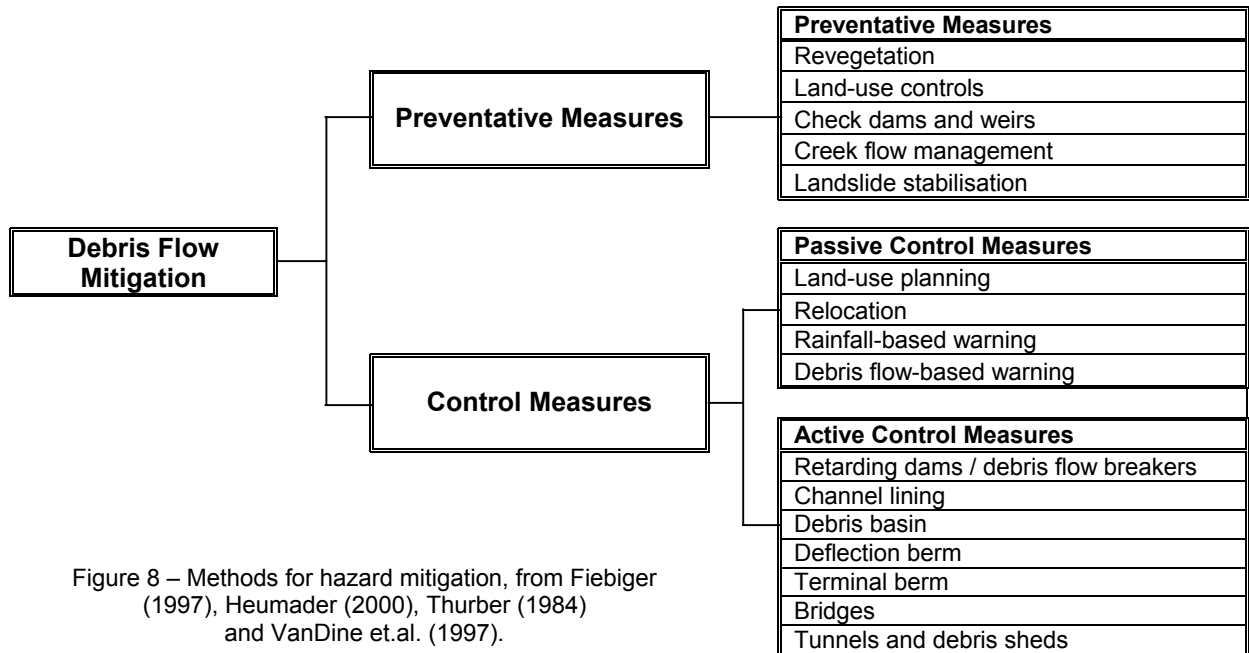
Figure 8 – Methods for hazard mitigation, from Fiebigler (1997), Heumader (2000), Thurber (1984) and VanDine et.al. (1997).

A review of risk reduction measures was undertaken. Risk reduction strategies fall into one of two broad categories; Preventative measures seek to reduce the likelihood that a debris flow will be triggered, while Control measures are designed to reduce or constrain debris flow damage (Figure 8).

Parks Canada has decided to proceed with the terminal berm concept. This option entails construction of a diversion berm at the fan apex, which would allow normal creek flows to continue along the east channel, while diverting floods and debris flows into the west channel.

Debris flows would be allowed to spread out over a portion of the natural fan, constrained by a terminal berm, constructed along the Fireside day use area access road.
