A Century of Landslide Activity in Glaciolacustrine Deposits in Jeffersonville, Vermont, USA

Springston, G.E. MSc., Sevi, Adam F. P.E. Ph.D. & Kanat, Leslie. Ph.D.

ABSTRACT

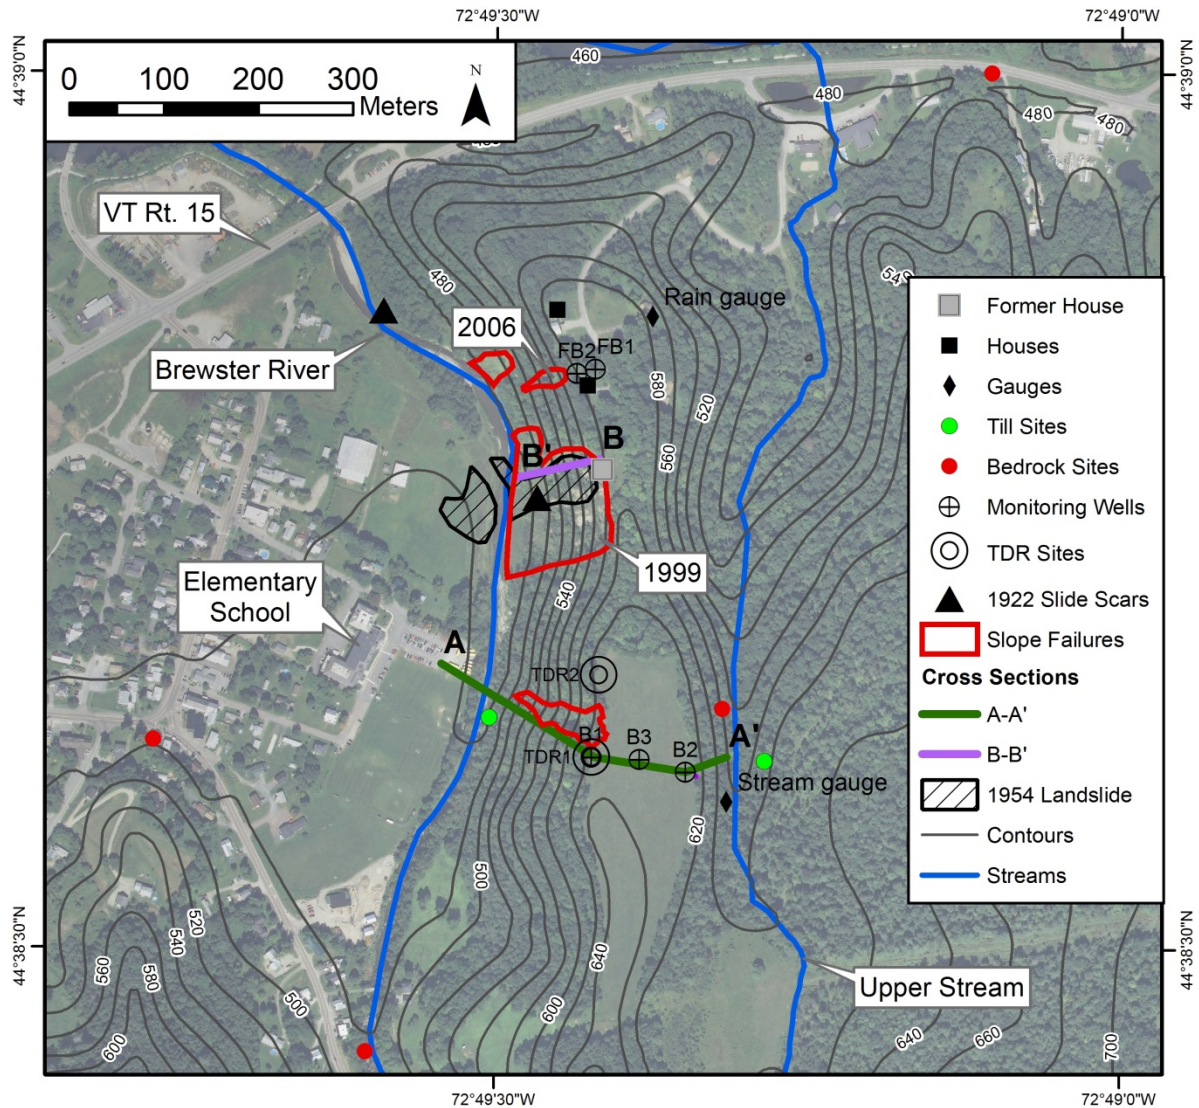
Figure 2. Map of site showing locations of present-day landslides, historic landslides, cross sections, borings, monitoring wells, stream gauge, and rain gauge. Two houses at the top of the slope are shown as black squares and a house removed after the 1999 slides is shown as a grey square. The base map is from 2008 true-color orthophotos and the 20-foot contours are from the U.S. Geological Survey.

A series of three landslides occurred at the site on 11 April, 18 April, and 4 July, 1999. The location is shown in Figure 2. These are described in detail in Bierman *et al.* (1999) and Wright (2003). Using the classification of Cruden and Varnes (1996), the landslides were complex translational to rotational earth slide-flows. Figure 11

failure. Instead, the cause appeared to be high pore-pressure due to heavy rains in the preceding weeks. Another landslide-gully complex is located directly opposite the Cambridge Elementary School (Figure 2) and has been actively eroding over at least the last 20 years. In April of 2009, accelerated slumping occurred at the head of this complex, apparently due to seepage forces due to snow-melt (Figure 7). Sediment from the slump flowed down and into the Brewster River. The stability of this section of the slope will be discussed in Section 5.1 below.
