Risk management framework and mitigation for rock fall hazard at the Clowhom River Hydroelectric Project, near Squamish, BC

Charles Hunt, Shelley Higman & Bob Patrick
Tetra Tech EBA, Vancouver, BC, Canada

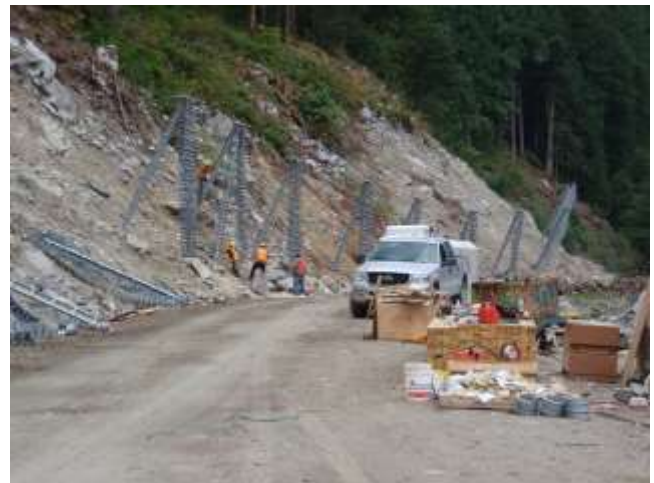
Figure 10: Installing the Fence Posts

The anchors were installed using an Air Track Drill Rig with an extending boom. Post anchors and lateral anchors were easily reached by the drill rig from the existing ditch along the edge of the FSR. At the locations where the drill rig was unable to climb the talus slope to reach upslope anchors for installation, benches were constructed above the ditch using logs and fill material derived on site. These benches allowed the drill rig to safely climb higher up the slope to reach the upslope anchor positions. In order to comply with the other works happening on the project site, including traffic passing along the FSR, the drill rig and benches were positioned in a fashion to prevent obstruction to other vehicles.
