Hydro-geomorphic response to the June 19-21, 2013 storm in Canmore and the Municipal District of Bighorn, Alberta

Matthias Jakob, Hamish Weatherly, Ashley Perkins, Stephanie Bale and Jamie Sorenson
BGC Engineering Inc, Vancouver, B.C., Canada
Rosie Howard, Roland Stull
Earth and Ocean Science Department, University of British Columbia, B.C., Canada
Andy Esarte
Town of Canmore, Alberta, Canada

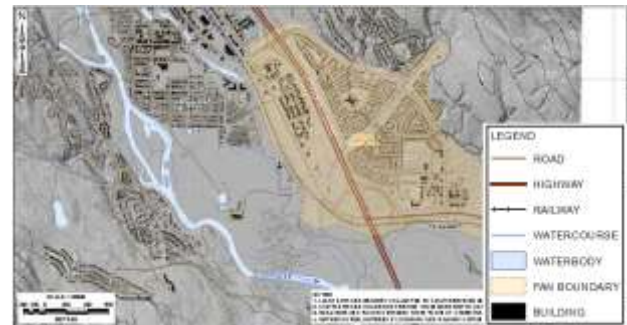
Cougar Creek fan has an area of 3.1 km² and is unlike most fans in the Canadian Rocky Mountains in that it is very densely developed, including 1417 residential homes; a number of lodges/resorts between Highway 1 and Highway 1A; a light industrial area in the southeast corner of the fan; one elementary school (Elizabeth Rummel); a heliport (Alpine Helicopter); numerous roads including a crossing of the creek at Elk Run Boulevard; Highways 1 and 1A; the Canadian Pacific (CP) Rail line; various municipal infrastructure (telecommunication lines, sewers, etc.); and powerlines (Figure 5).

Figure 5. LiDAR-generated shaded relief image of Cougar Creek fan and Infrastructure.

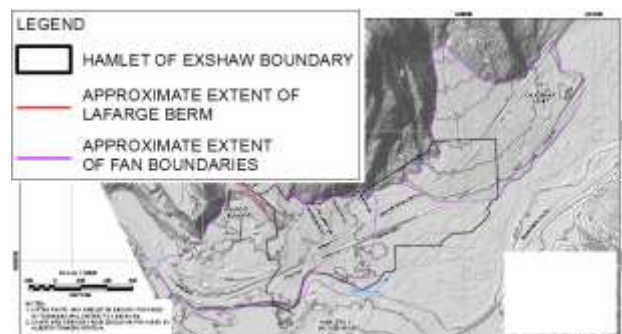
Jura Creek and Exshaw Creek are south flowing tributaries that discharge into Bow River at the Hamlet of Exshaw (Figure 11). Similar to Cougar Creek, both creeks were impacted by debris floods during the June 2013 rainstorm, with major volumes of sediment transported to their respective alluvial fans.

Figure 11. Exshaw and Jura Creek LiDAR-based topography and fan outlines.

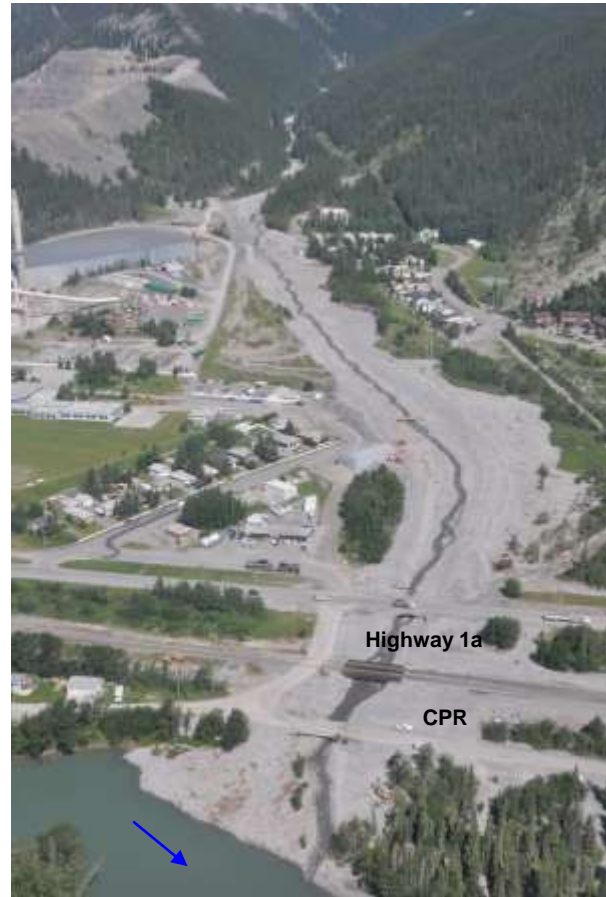
From the fan apex at elevation 1340 m, Exshaw Creek flows for about 800 m before reaching the bridge crossings of Highway 1A, the CP Railway, and a secondary road (Figure 12). Just downstream of this final bridge, Exshaw Creek discharges into Bow River. The Hamlet of Lac des Arcs is located directly opposite of Exshaw on the fan of Heart Creek, on the south side of Bow River.

Figure 12. Exshaw Creek looking upstream with Bow River in the lower left hand corner. The industrial complex on the left in mid fan is Lafarge cement. The Hamlet of Exshaw is mostly on the right (east side) of the fan.
