**Geotechnique and Natural Hazards**

**TECHNICAL TOURS GUIDEBOOK, MAY 7, 1992**

**PETER BYRNE  
JOHN J. CLAGUE  
ROBERT F. GERATH  
OLDRICH HUNGR  
JOHN LUTERNAUER  
ERNIE NAESGAARD  
K. W. SAVIGNY  
NIGEL SKERMER**

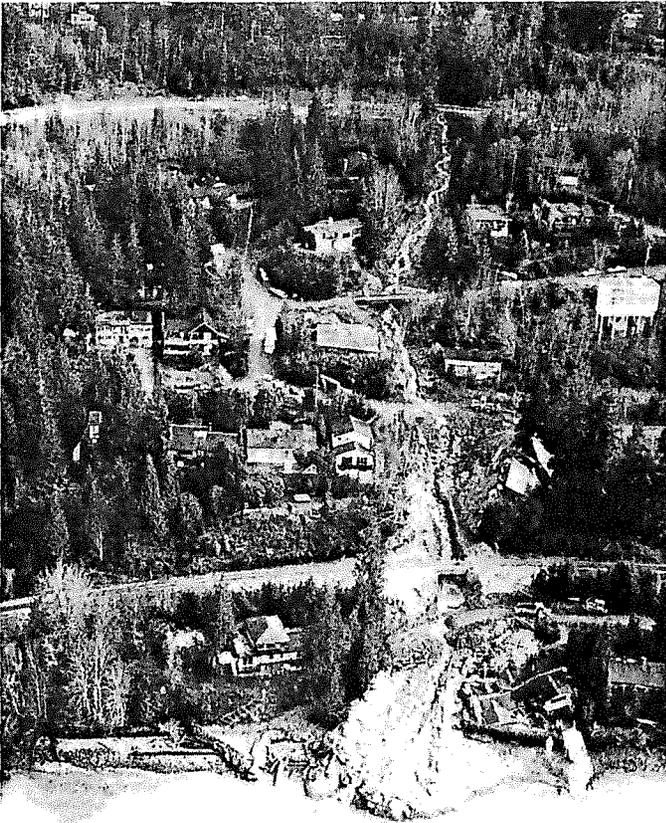
Destruction resulting from  
1983 Debris Torrent

Proposed Channelization

Figure 6 Alberta Creek debris channel. (From a sketch drawing by Ker Priestman Associates Ltd. Photo D.F. VanDine)

Alberta Creek offers no suitable sites for a retention structure, due to steep slopes and dense population. Consequently, a 700m long "shooting channel" (from German "schussrinne") was built, to deliver flood or debris flow discharges to the toe of the fan in Howe Sound (Figure 6). The design of the channel was based on semi-empirical formulas for debris flow hydraulics, developed by back-analysis of observed events (Hung et al., 1984). Two main considerations in the design were a) to prevent spillover at bends by providing a uniform, gently curving channel and b) to prevent depositional plugging by ensuring secure confinement of the flow at a range of discharge rates. The lined channel was also used to stabilize steep eroding banks which threatened a number of houses upstream of the fan.

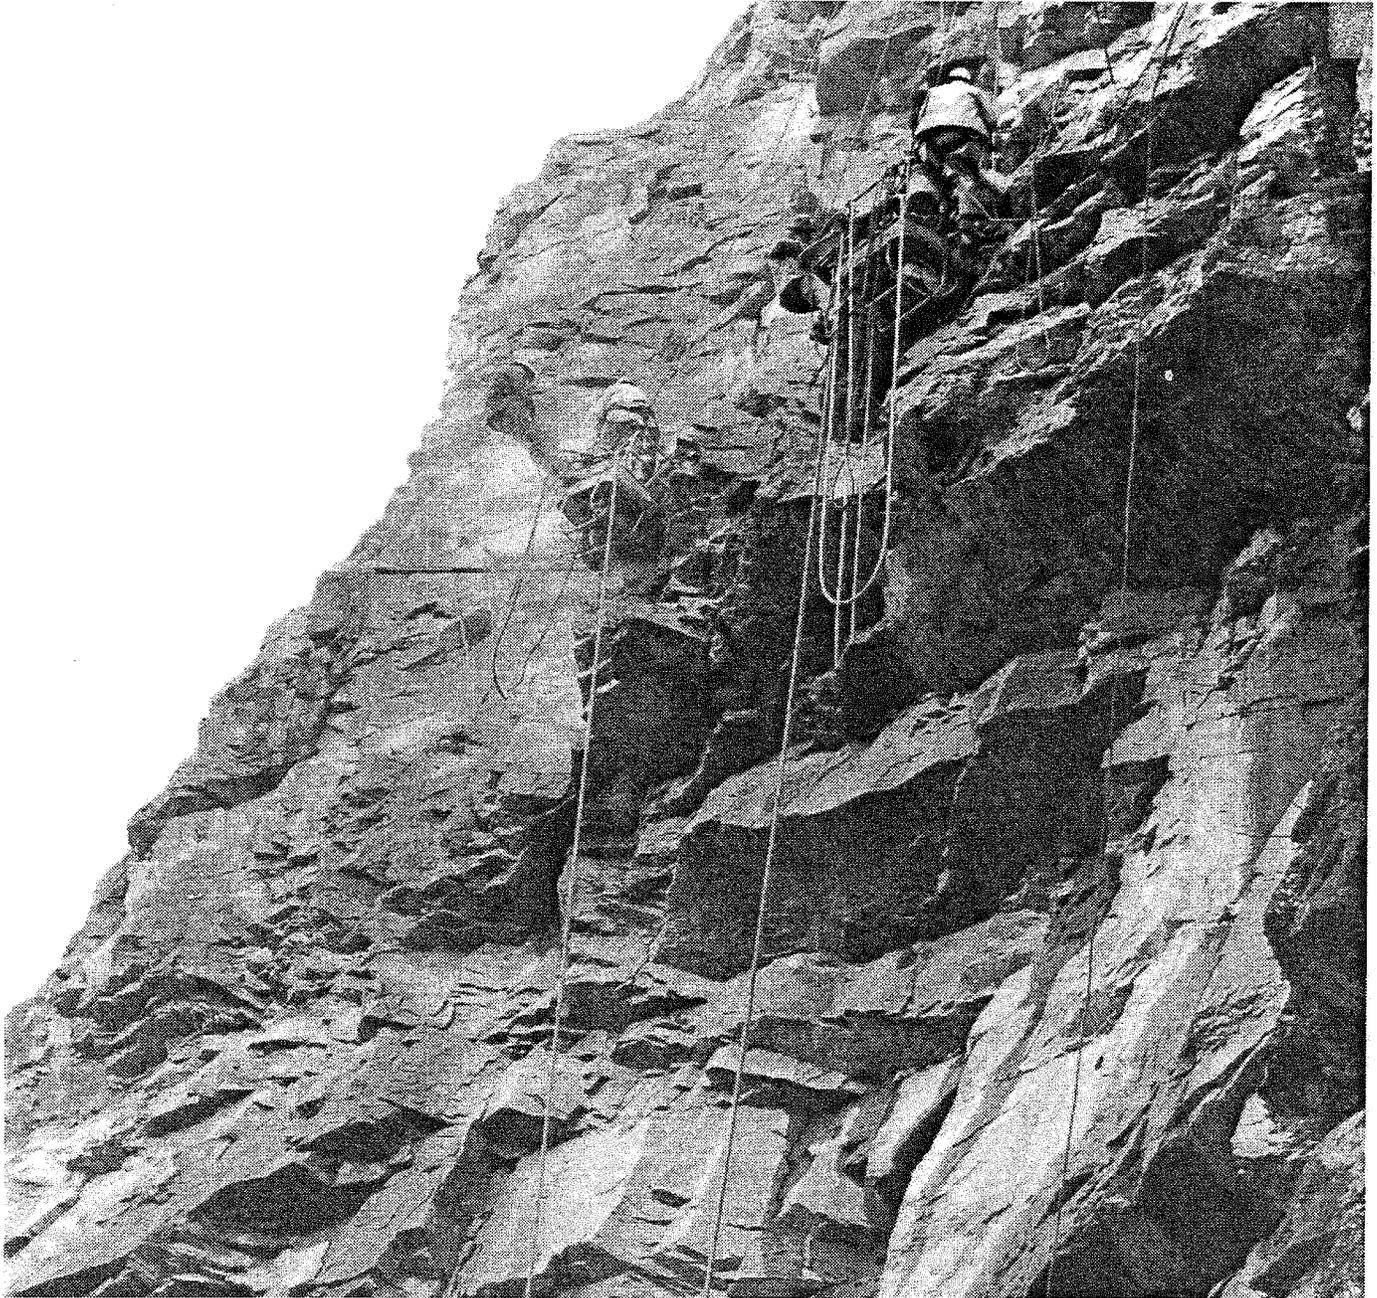
Figure 10 Rock bolting with a bencher drill on the Squamish Highway (Photo courtesy B.C. Ministry of Transportation and Highways).

A major scaling and stabilization program was completed at Porteau Bluffs by the Ministry of Transportation and Highways in 1991. The cliffs were cleared of vegetation and thoroughly scaled. Some 3,000 metres of galvanized steel resin grouted threadbar anchors were installed, some as long as 10 m. Permanent displacement prisms were attached for long term monitoring. Figures 9 and 10 show scaling operations in progress on the cliffs.

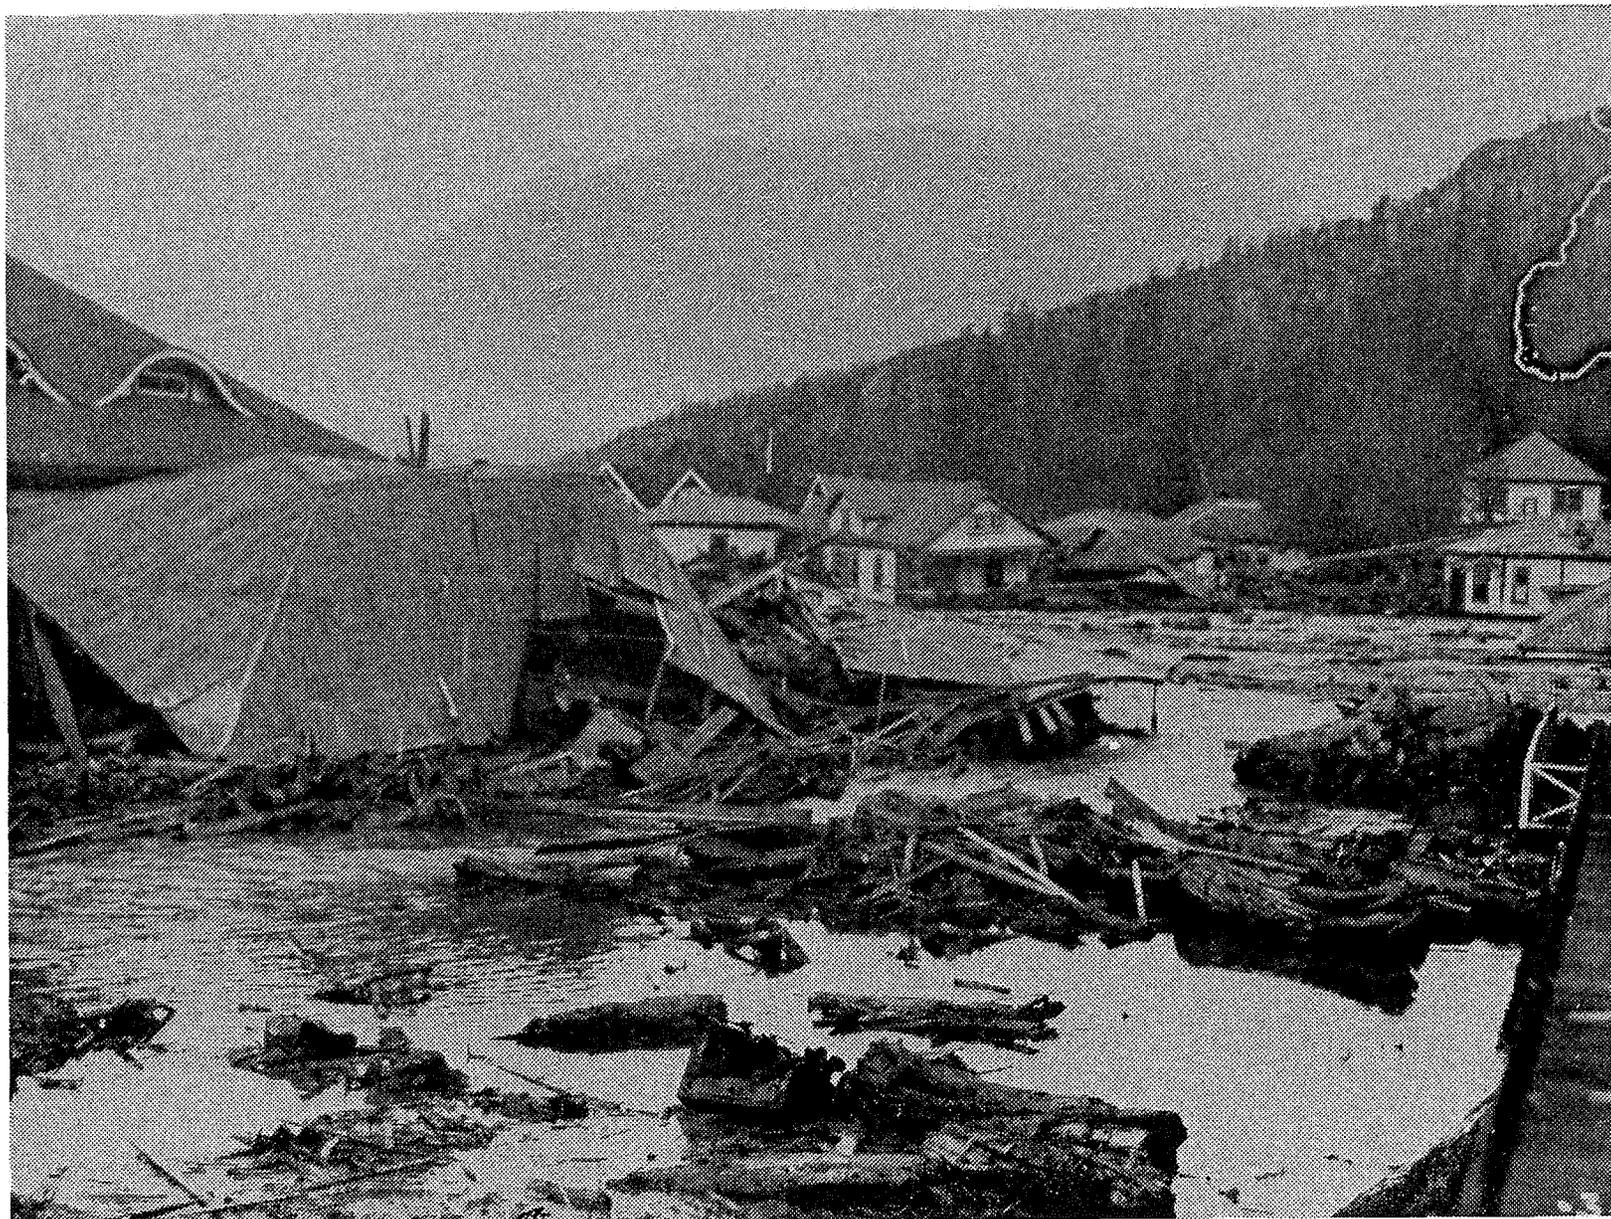
Figure 13 The 1921 flood damage on the fan of Britannia Creek (photo courtesy Vancouver Public Library).

The Britannia Creek basin had lost most of its forest cover due to the initial mineral exploration and development work. The creek is 8.5 km long with a drainage area of 28.5 km<sup>2</sup> and gradients in the range of 3° to 11°. A sudden outburst debris flood occurred at 9:30 a.m. on the evening of Friday, 28 October 1921. At first it was believed to be the result of the collapse of natural dam of timber and soil debris that had slid from the banks of the creek and temporarily ponded water. Later at the inquest civil engineers testified that, rather than a natural dam, the cause lay in the collapse of a culverted fill that carried the mine's railway across the creek. The 2.5 m wooden culvert became plugged with debris, ponding 60,000 m<sup>3</sup> of water before it failed. When the fill collapsed the surge ("a wall of water 70 ft. wide by 3 to 5 ft. high") destroyed 60 houses in the mining community built on the fan, see Figure 13 from the Province newspaper at the time. Thirty-seven people perished. The flood occurred after days of heavy rain culminating in a cloudburst that yielded an "unprecedented" 146 mm in the 24-hour period immediately prior to the flood. Conditions were made worse because "a warm Chinook wind was blowing, which melted the snow in the mountains, adding their quota of water to the already swollen stream." The coroner's inquest found the mining company criminally negligent. Further details are given in Skermer and Russell (1988).

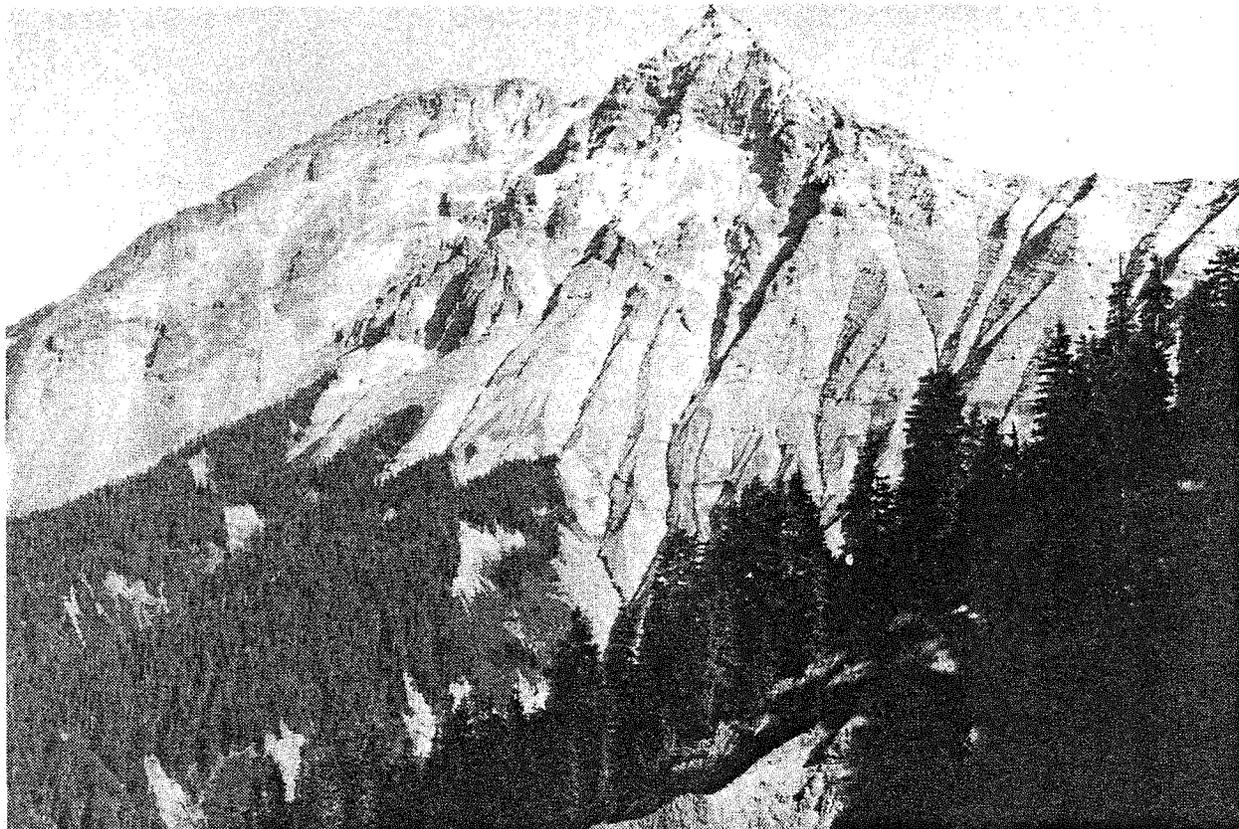
Figure 16 The west face of Atwell Peak (right) and Dalton Dome (left), taken from Cheekye Ridge.

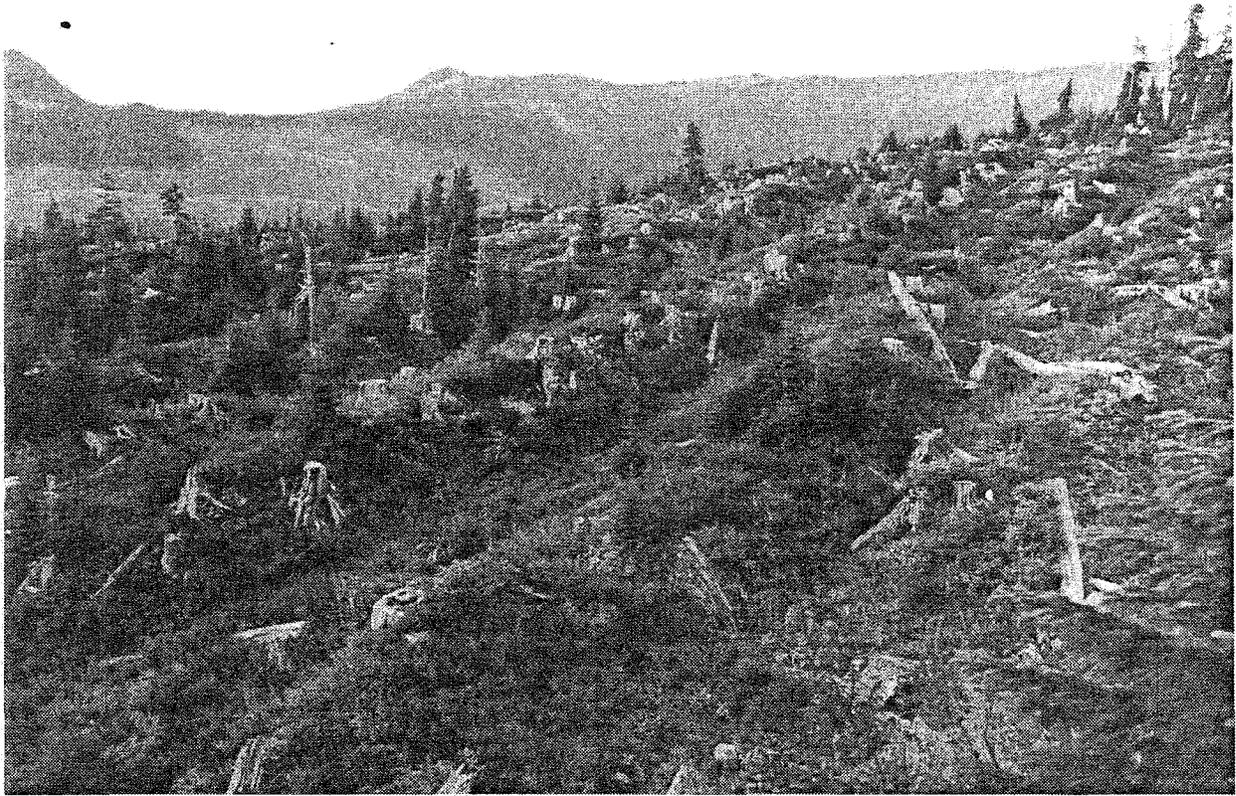
Figure 20 Linear scarps on Cheekye Ridge. The valley is to the left.

Both ridges bordering the Cheekye drainage have large fields of ancient cracks and scarps, indicative of slope instability (Figures 19 and 20). The scarps stand at the angle of repose (40 degrees) where formed in the pyroclastics or vertical in lava. They are generally 2 to 5 m high, with a few ranging as high as 20 metres. The major scarps have steep sides dipping downslope, indicating normal displacements. Many of the smaller scarps indicate reverse movement, often combining with the former to form grabens.

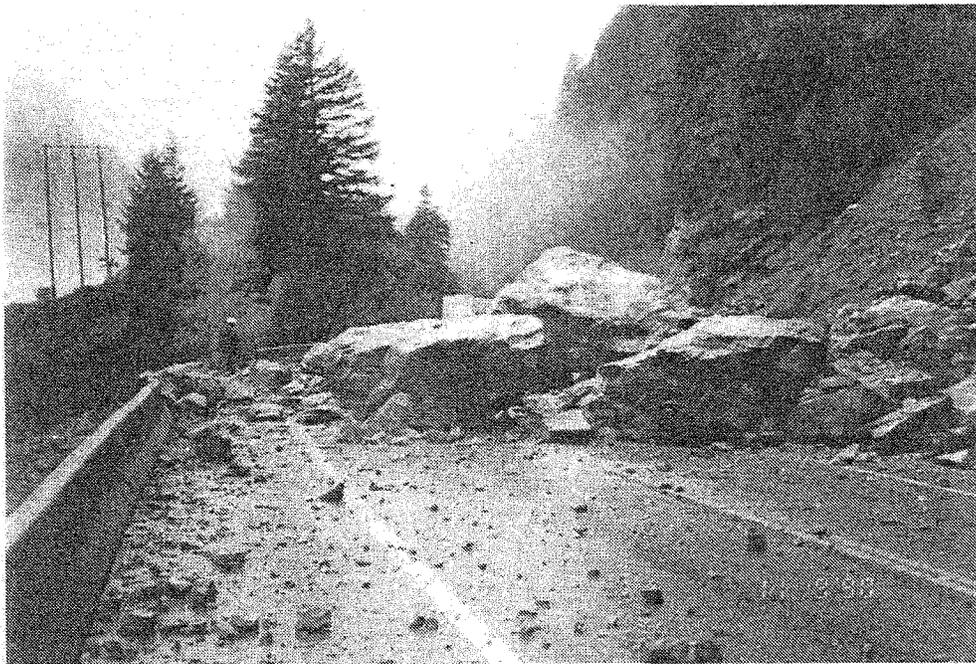
Figure 25: Highway blocked by rockfall in very strong, massive granite that originated from approximately 300 m above the highway and destroyed a 3 m high concrete wall.

of rock cuts and tunnels, most of which are unsupported. Blasting was required for almost all the rock excavation, and the blasting methods used often resulted in substantial overbreak and shattering of the rock behind the face. As a result, most of the rock in exposed faces is highly fractured. The combination of the shattered rock and the weather results in loosening and failure of blocks on the faces. Most of these failures occur in the spring and fall when precipitation levels are high and freeze/thaw cycles occur. Figure 25 shows one such failure which occurred in November 1990 following a period of heavy rain.

Protection can be provided by a variety of structures placed on and at the toe of the slope. These structures include catchment ditches, mesh, fences and rock sheds. A common feature of all these protection structures is their energy-absorbing characteristics: the rockfall is either stopped over some distance or deflected away from the facility that is being protected. It is possible, by using appropriate techniques, to control rocks as much as 2 to 3 m in diameter, falling from heights of several hundred metres. In contrast, rigid structures, such as reinforced concrete walls, are rarely effective for catching rockfalls; the rock fall in Figure 25 completely destroyed a 3 m high concrete wall.
